12
PTPT REPORT NO. 78-6
AFPEA PROJECT NO. 77-P7-42

"OUT OF CONTAINER" HANDLING ANALYSIS
OF THE LN-15 INERTIAL MEASUREMENT UNIT

HQ AFALD/PTP
AIR FORCE PACKAGING EVALUATION AGENCY
Wright-Patterson AFB OH 45433

March 1978

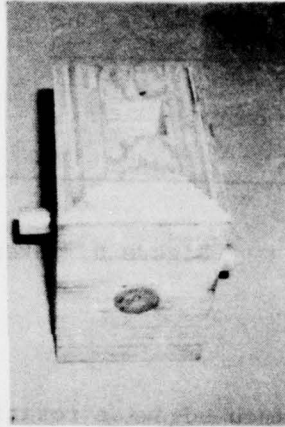
Figure 4. Model with Simulated Hose Fittings

Simulated hose fittings were added to the wooden model of the LN-15 (Figure 4) and the "hose fitting" lift technique was performed. During the lifting process, the model was allowed to rotate and hit the floor (Figure 5).

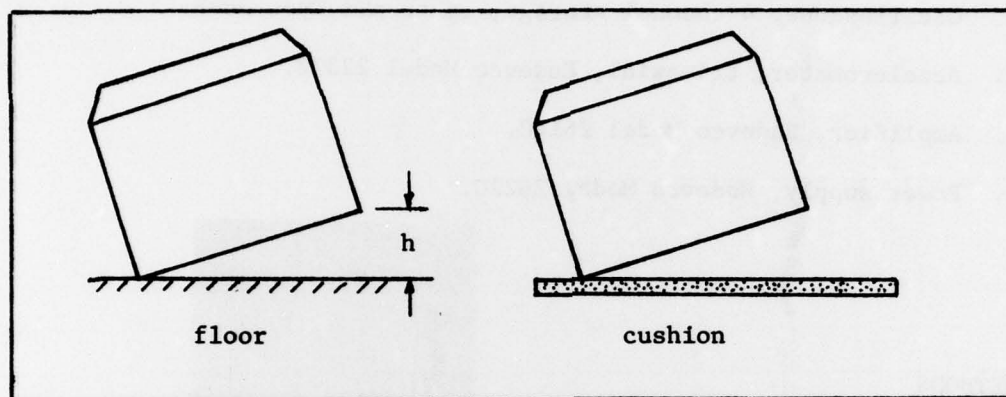
Figure 6. Sketch of Test Method

Since this method was difficult to control and the results were not repeatable, a two and four inch edgewise rotational drop test was used to simulate the impact force an IMU may receive during this rotational lift and drop process. The method is shown schematically in Figure 6 with and without a protective cushion on the floor.

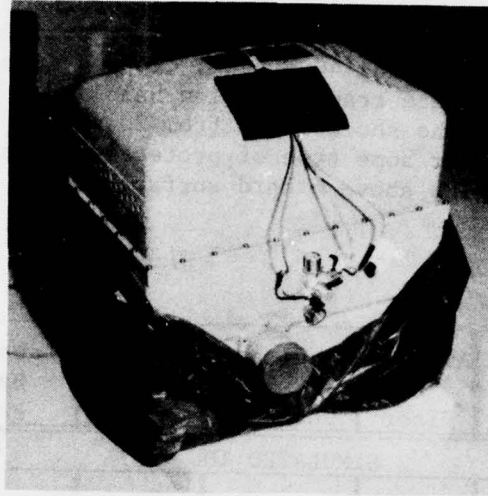
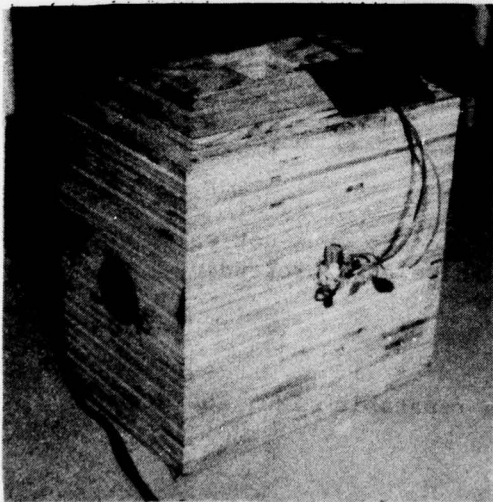
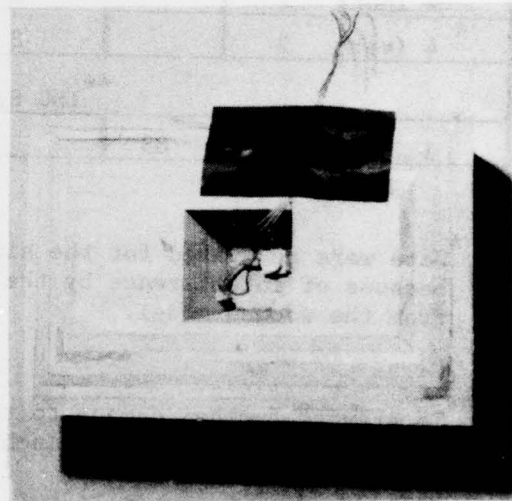
Figure 7. Accelerometer Location

A tri-axial accelerometer was secured to the simulated model and the actual IMU, as shown in Figure 7, to record the impact forces along the x, y and z axes.
